Whitman County Harlan Bridge

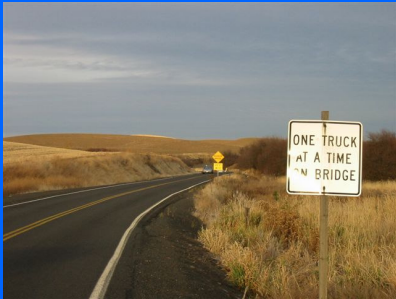
Load Posting

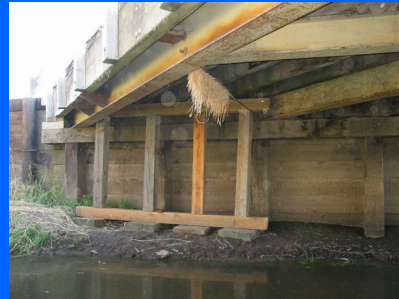
Temporary Bent on Mudsills

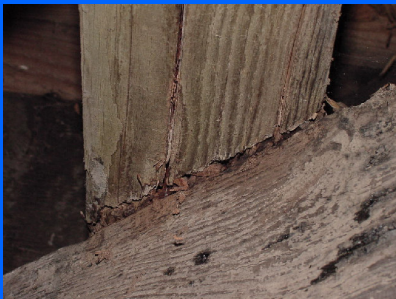
Rotten Crushing Stringers at Abutment

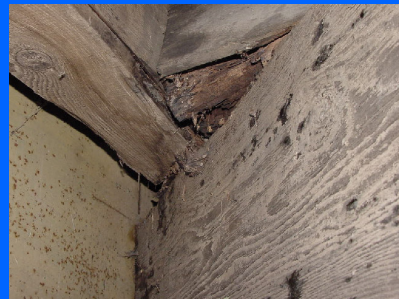
Rotten Blocking and Stringer

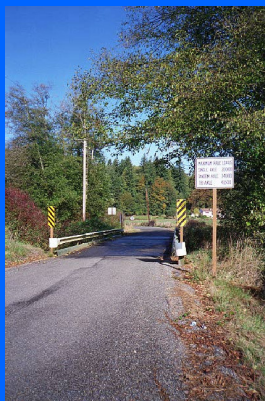
Load Posting

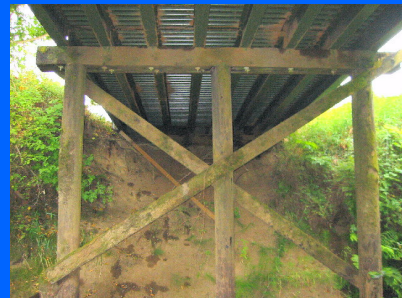
Bank Sloughing on Mudsill End

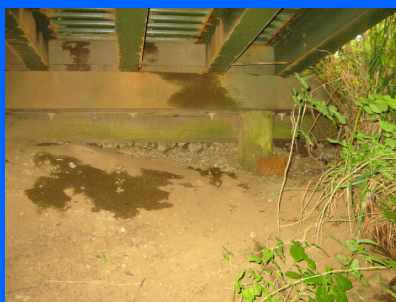
Mudsill Timber Abutment

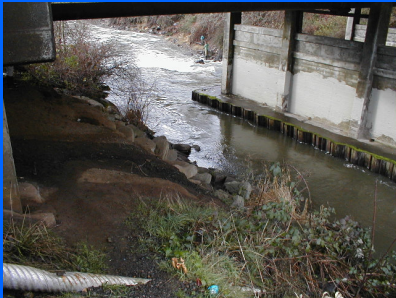
Center Pier Mitigation and Headcut
Downstream

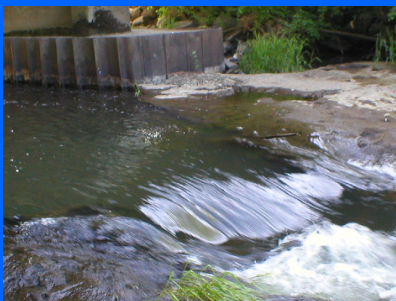
Headcut Downstream of Center Pier

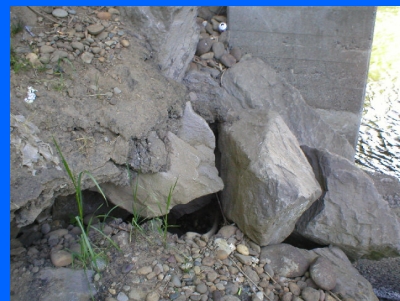
Attempted Riprap Mitigation

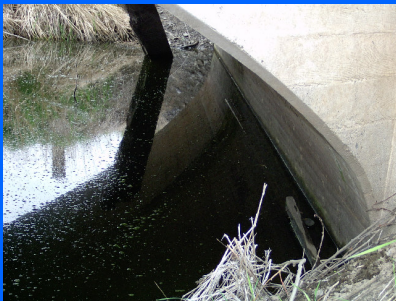
Scour at Abutment

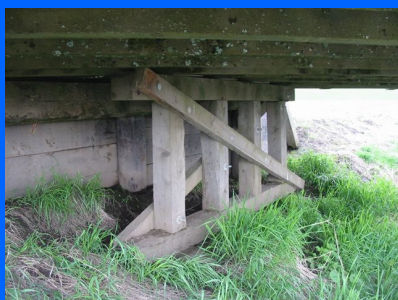
Temporary Bent

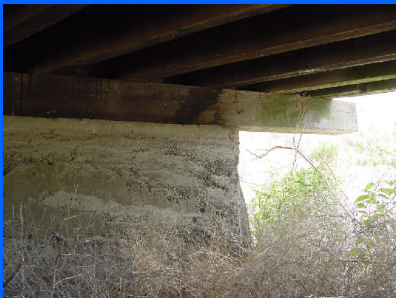
Deck Cantilever

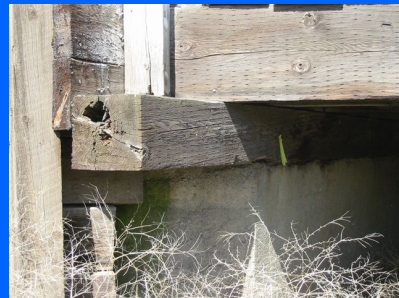
Rotting Abutment Cap

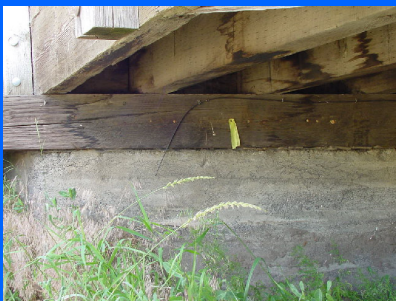
Abutment Wall and Rotting Timber Cap

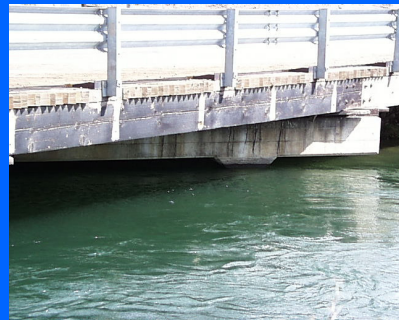
Concrete Substructure/Timber Superstructure

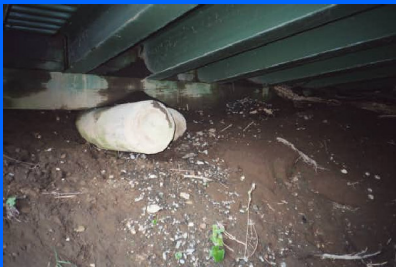
One Abutment on Log Raft Mudsill

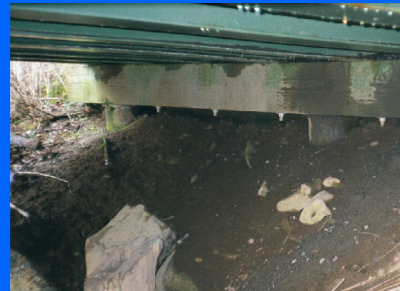
One Abutment on Widely Spaced Piles

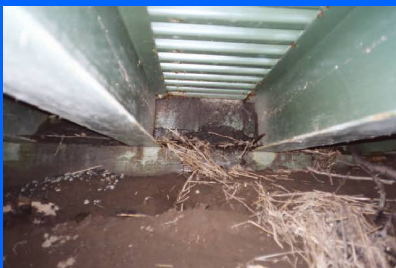
Evidence of High Water at Mudsill

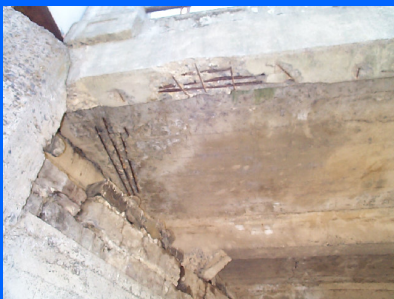
Outside Beam Bearing

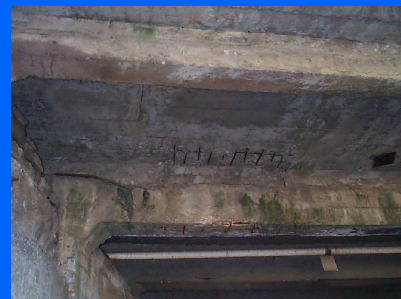
Outside Beams are Shallower than Interior

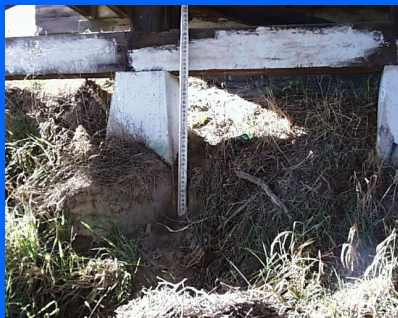
Bottom of Foundation Pier

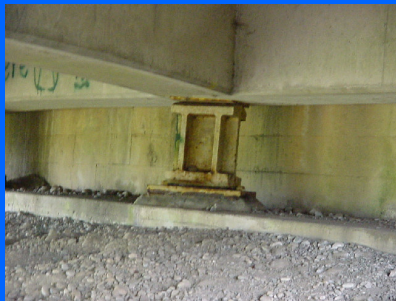
Seismically Vulnerable Tall Bearings

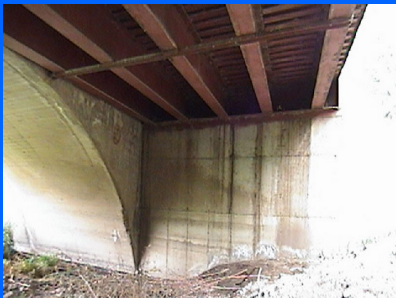
Widened Earth Filled Arch

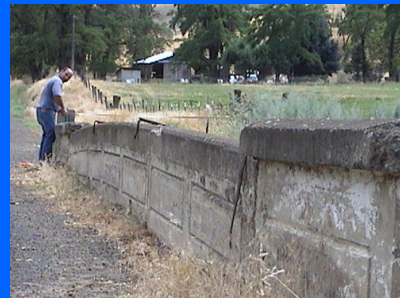
Settlement at Scouring Abutment

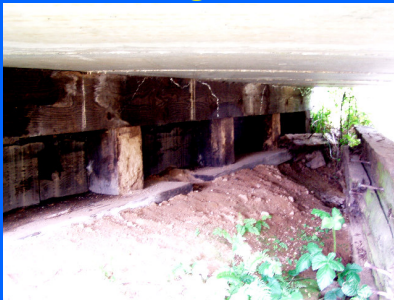
Mudsill Foundation

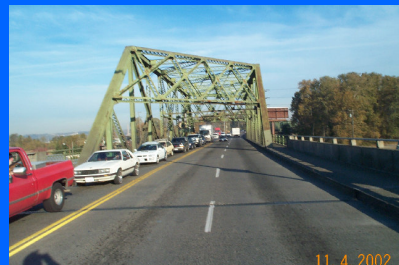
Traffic Back-up at Portland Avenue

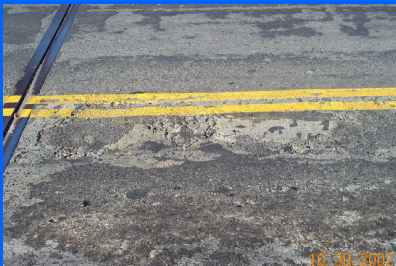
Deck Patching

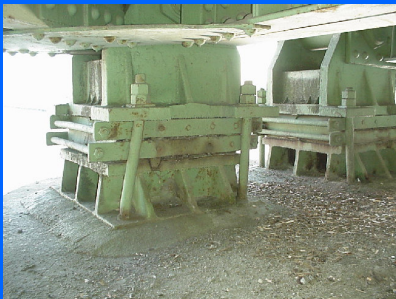
Typical Bearing Condition

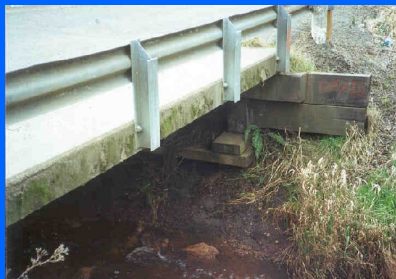
Slab Bridge on Scouring Mudsills

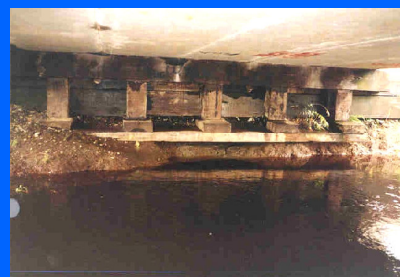
Scouring Mudsill

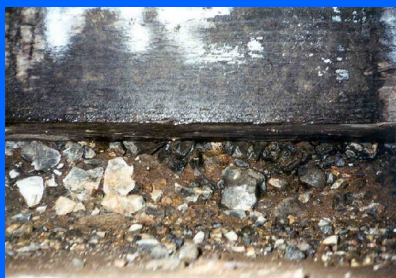
Undermining Mudsill

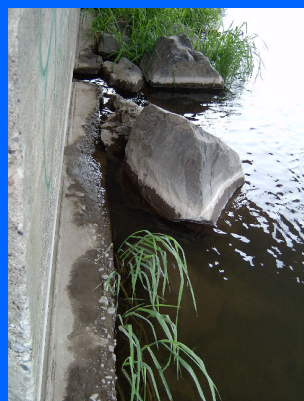
Scour at Center Pier and Riprap Mitigation

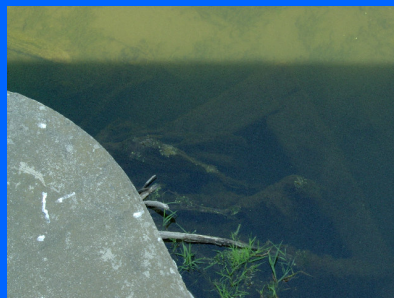
Exposed Construction Formwork

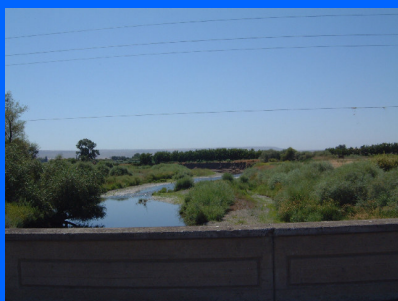
Channel Erosion

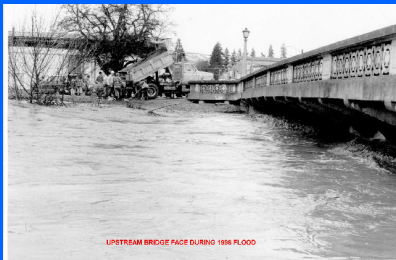
1996 Flood

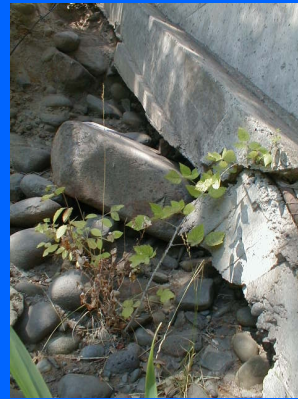
Abutment Scour

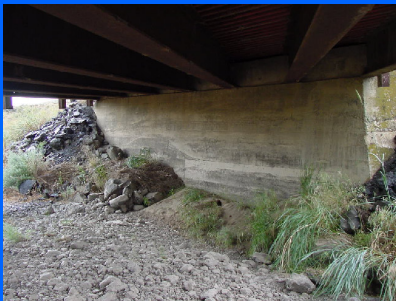
Previous Mitigation and Subsequent Scour

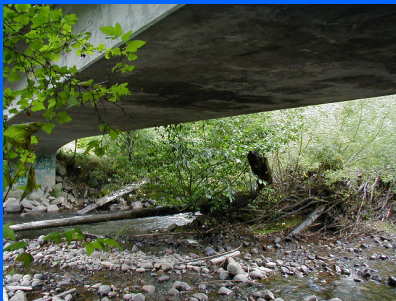
Split Channel Causing Scour Problems

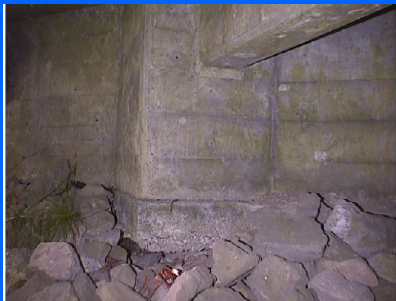
Scour at Abutment
